AFWAL-TR-79-3095
VOLUME II

ADVANCED RESIDUAL STRENGTH DEGRADATION RATE
MODELING FOR ADVANCED COMPOSITE STRUCTURES
VOLUME II - TASKS II AND III

Lockheed-California Company
Burbank, California

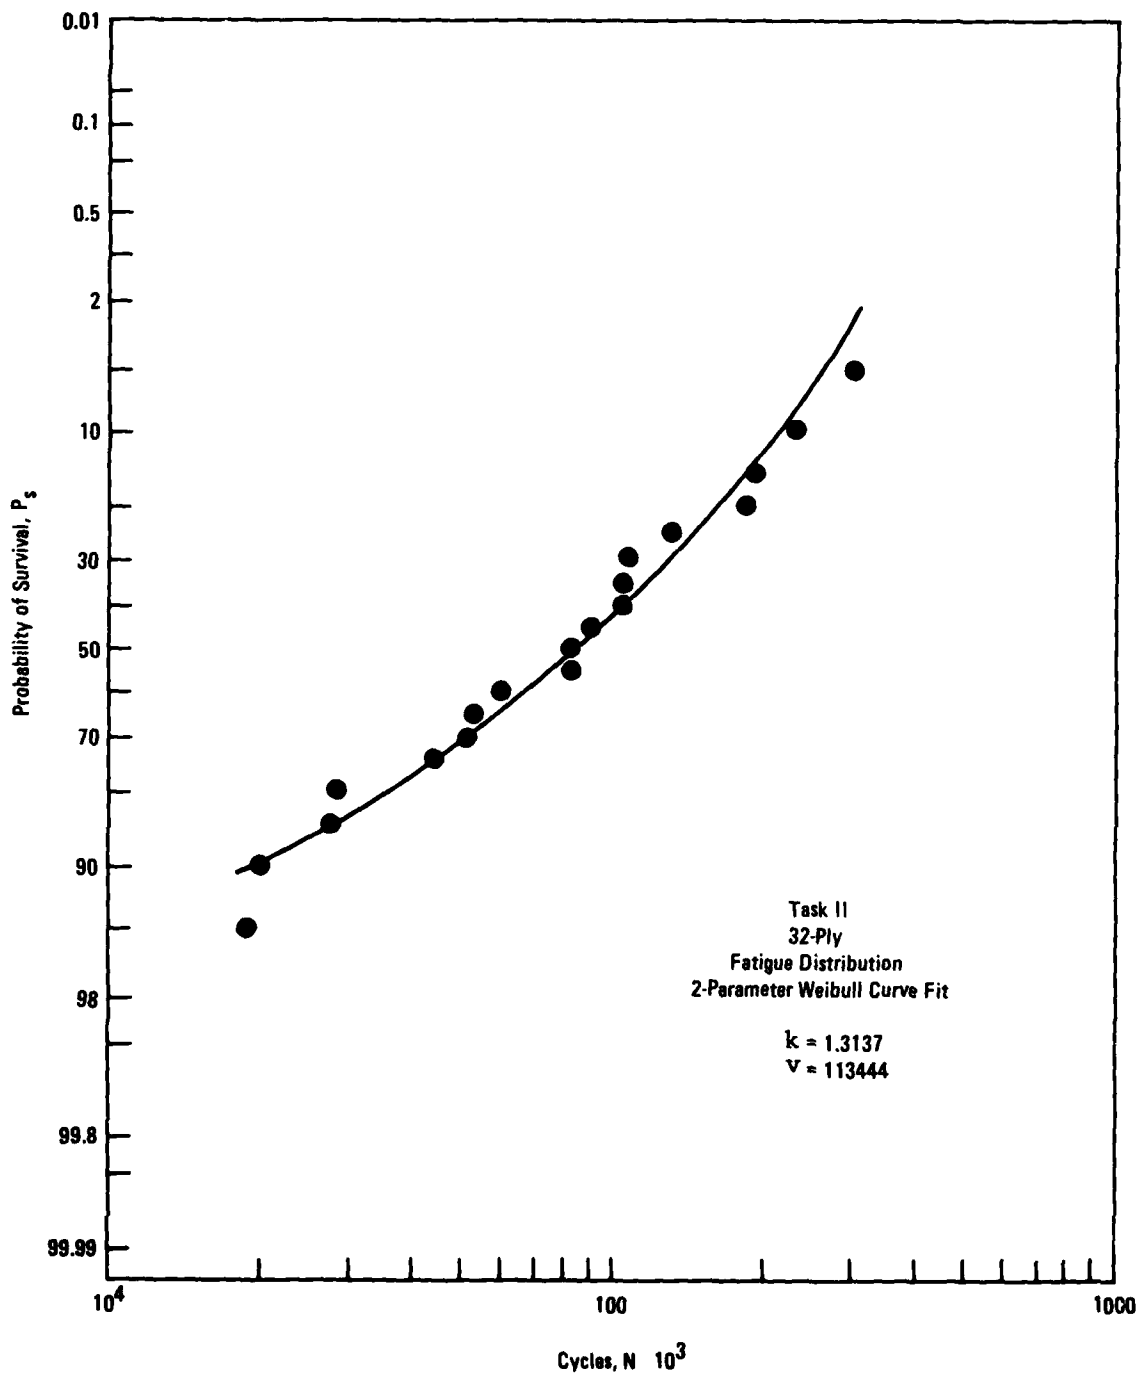
Figure 61: Two Parameter Weibull Curve Fit for Task II, - 32-Ply Fatigue Data, $\sigma_{Max} = 22$ ksi (152 MPa), $R = -1$

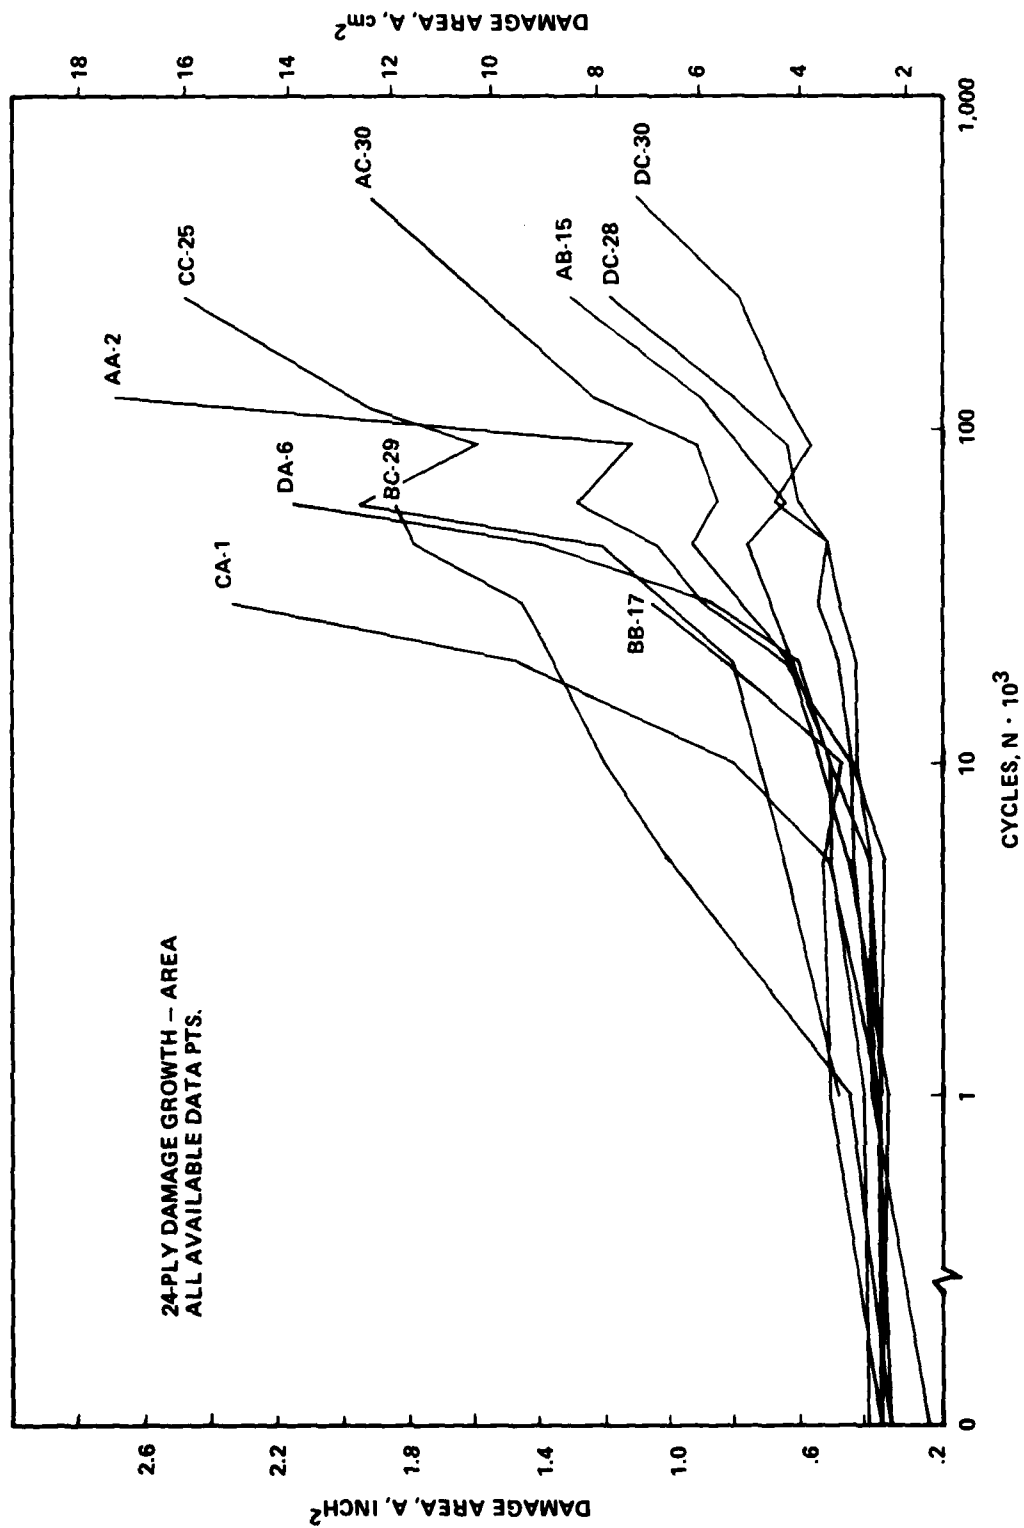
Figure 64a: Area Damage Growth for the 24-Ply Fatigue Distribution Specimens (Specimens 1 thru 10).

The general shapes of the damage vs N curves of Figures 64 - 66 are very similar to a vs N curves obtained for metals but the scatter is considerably larger. Area and width data exhibit coefficients of variation on the order of twice those for the growth in the Y direction. However, because Y-direction growth is the most uniform and orderly it is least likely to correlate to life. If a relationship between damage size and life existed, the larger dispersion in life data would require a large variation in damage size at any given number of cycles. This would also be true if the residual strength were expected to degrade to the fatigue stress. Examination of the Holscans indicates that the major growth occurs in the X not Y direction. Moreover, failures occurred during the compressive load excursion due to instability. Damage growth strictly in the specimen length (Y) direction for a specimen supported as in this study would not be expected to significantly affect the specimen stability and thus the life. Accordingly, if the failure problem is one of stability, neither damage width nor area may be expected to relate to life directly, except for a generally higher probability of failure as damage grows. That this is, in fact, the case is evident from Figures 69 and 70 which present in two different forms the lack of correspondence between damage size and fatigue life. This lack of relationship is also immediately apparent upon examining the initial flaw sizes which do not vary greatly and noting the factor of 30 difference in life. Clearly inspection for initial flaw sizes can offer no better than a prediction within 2 orders of magnitude.

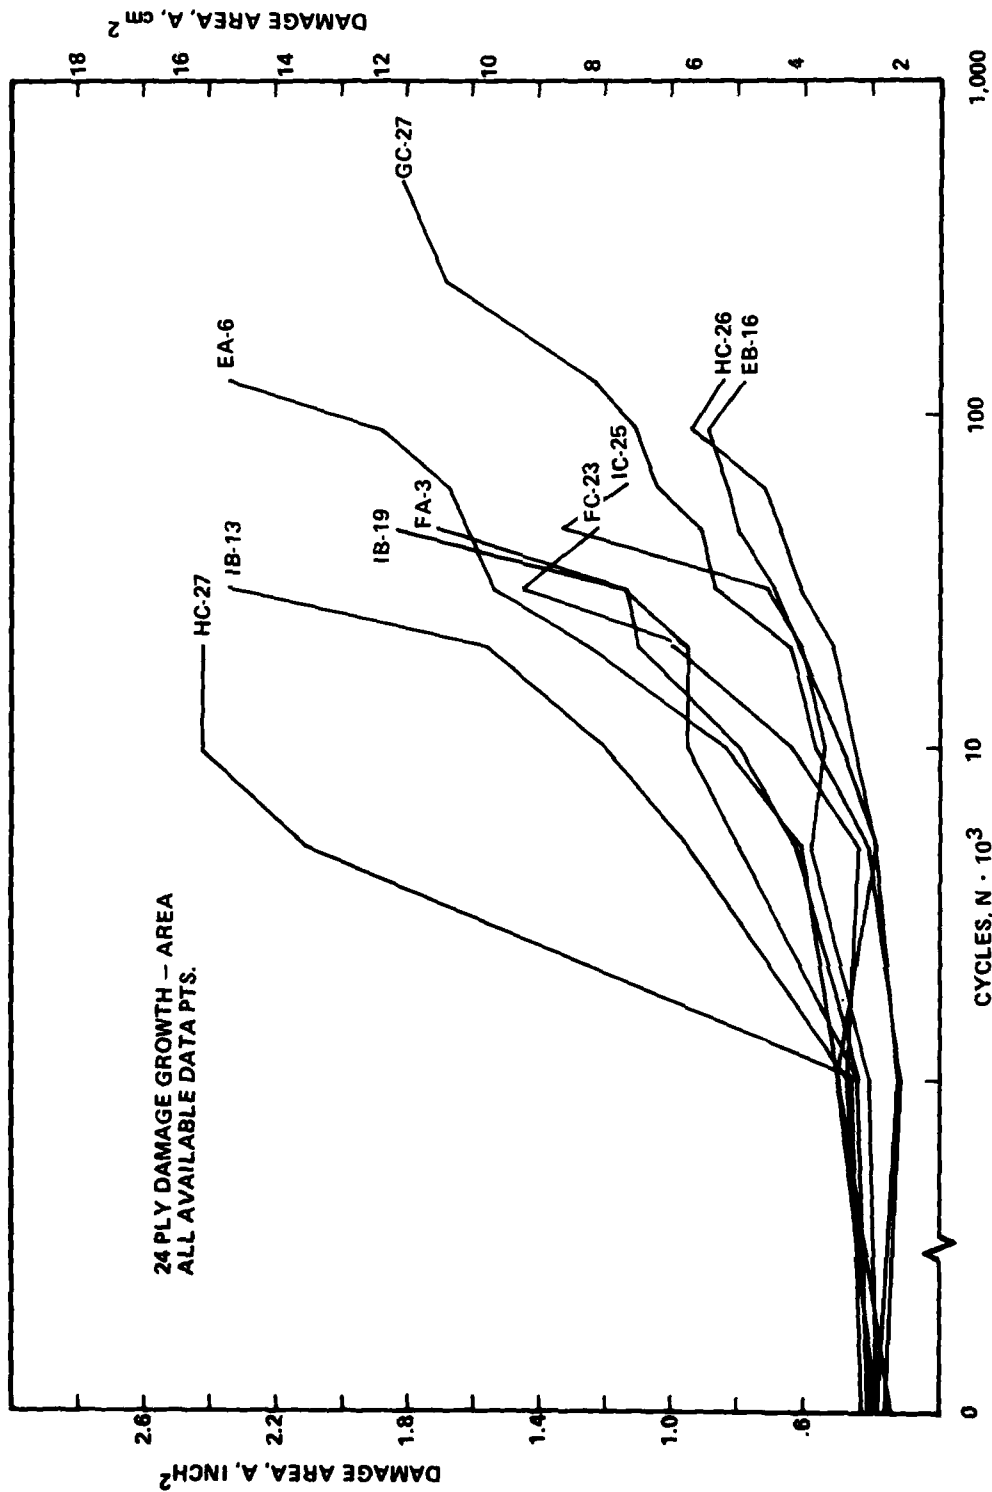
Figure 64b: Area Damage Growth for the 24-Ply Fatigue Distribution Specimens (Specimens 11 thru 20).

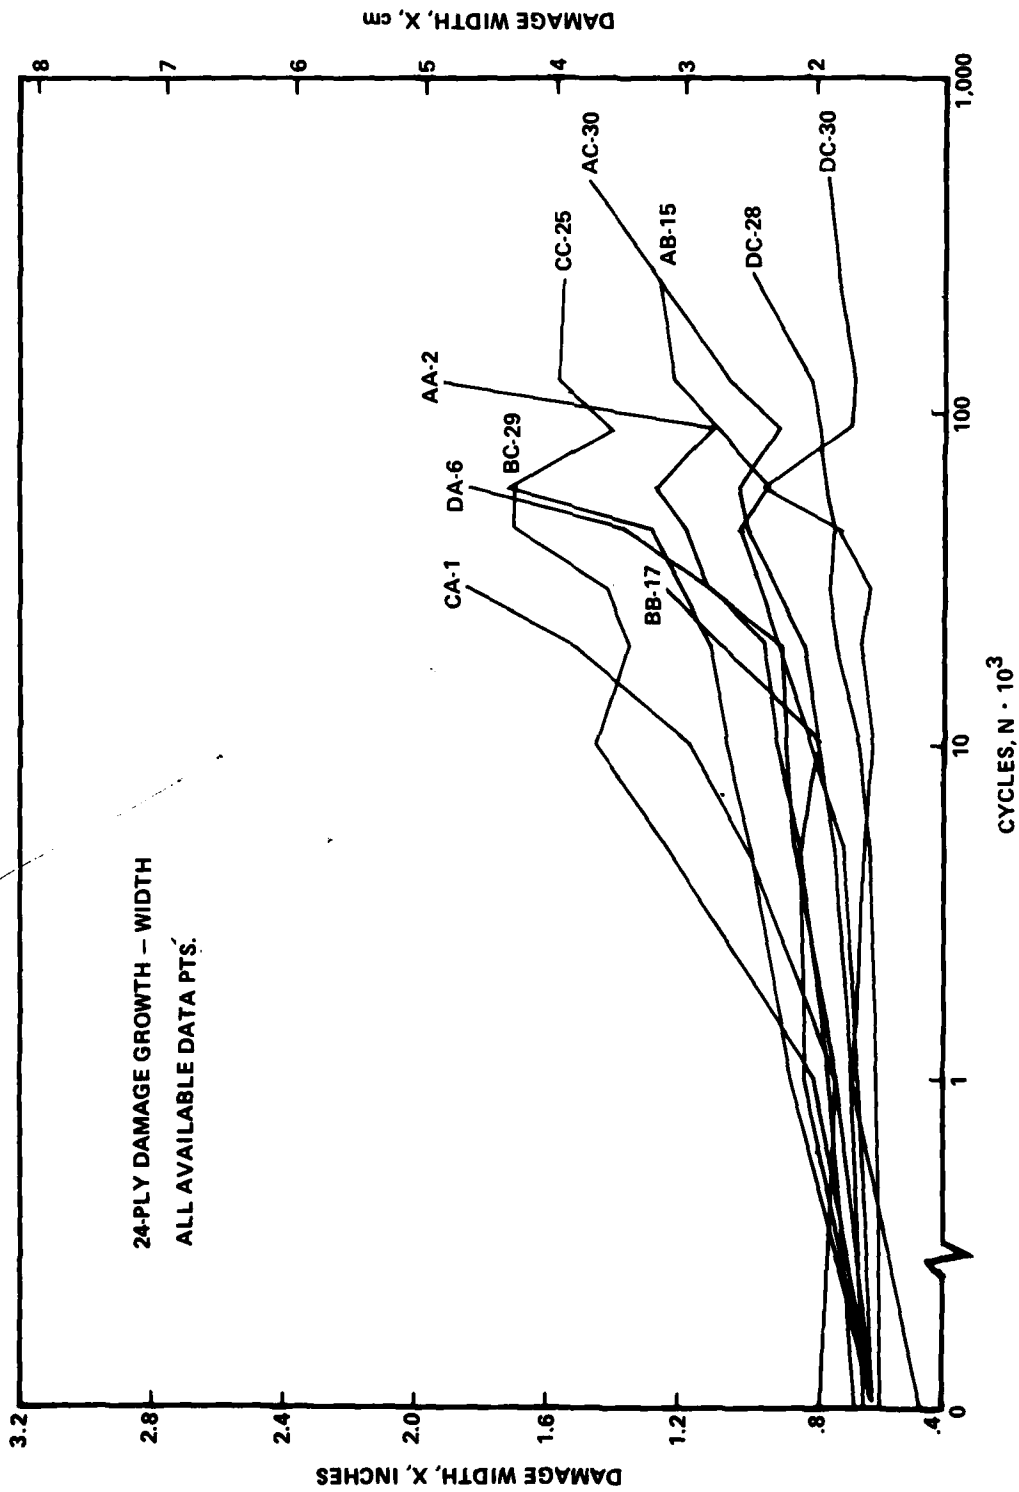
Figure 65a: Damage Growth in Width Dimension for the 24-Ply Fatigue Distribution Specimens (Specimens 1 thru 10).

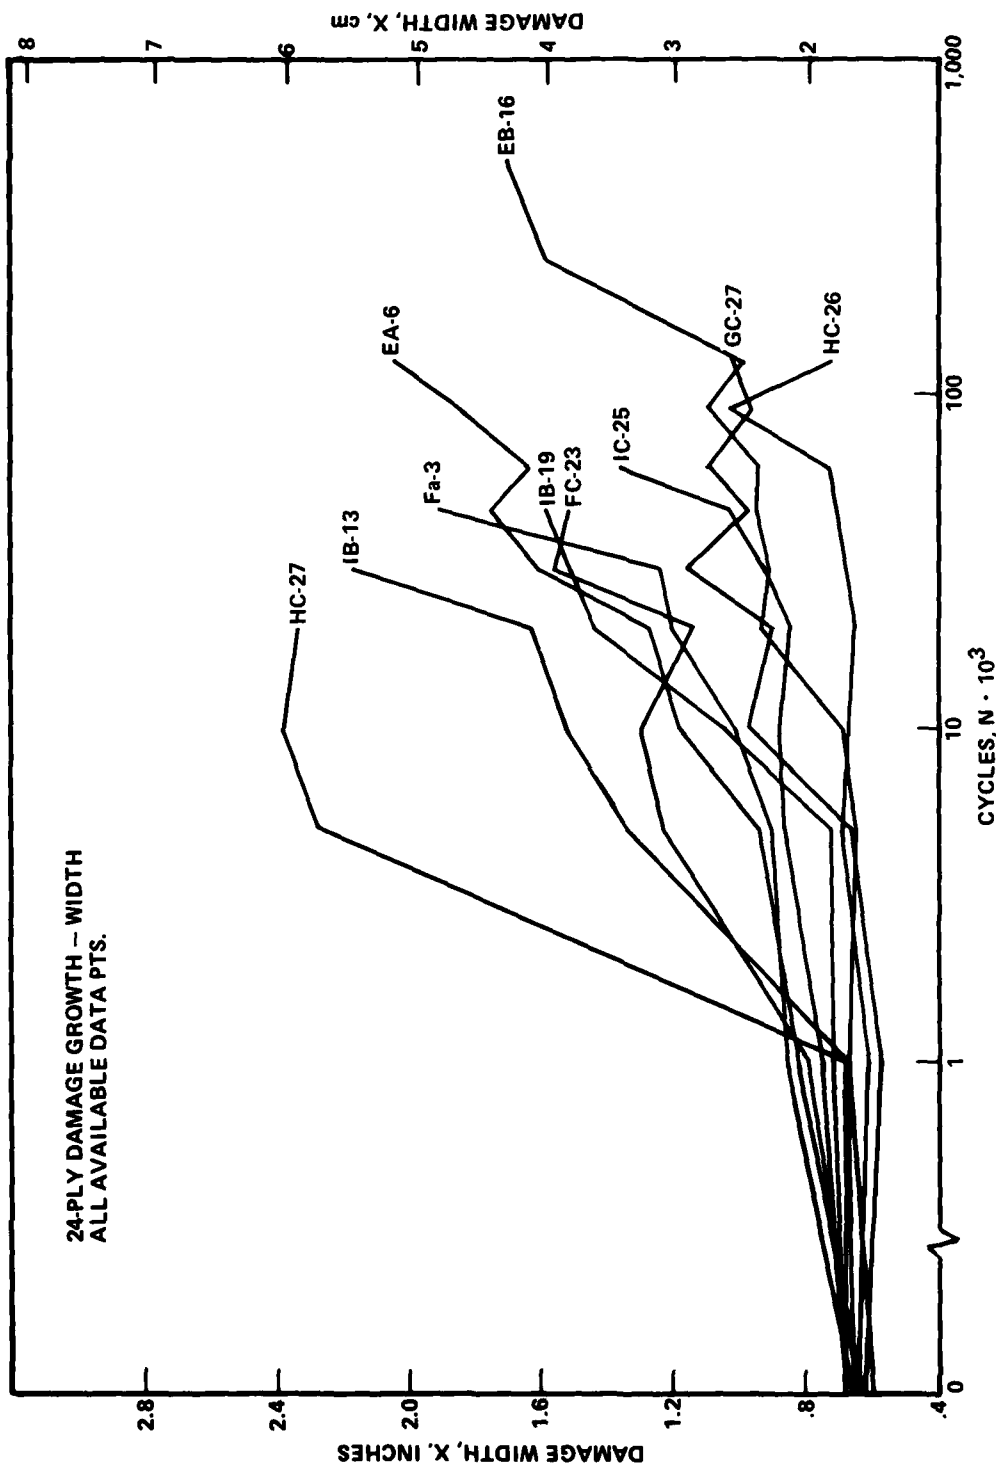
Figure 65b: Damage Growth in Width Dimension for the 24-Ply Fatigue Distribution Specimens (Specimens 11 thru 20).

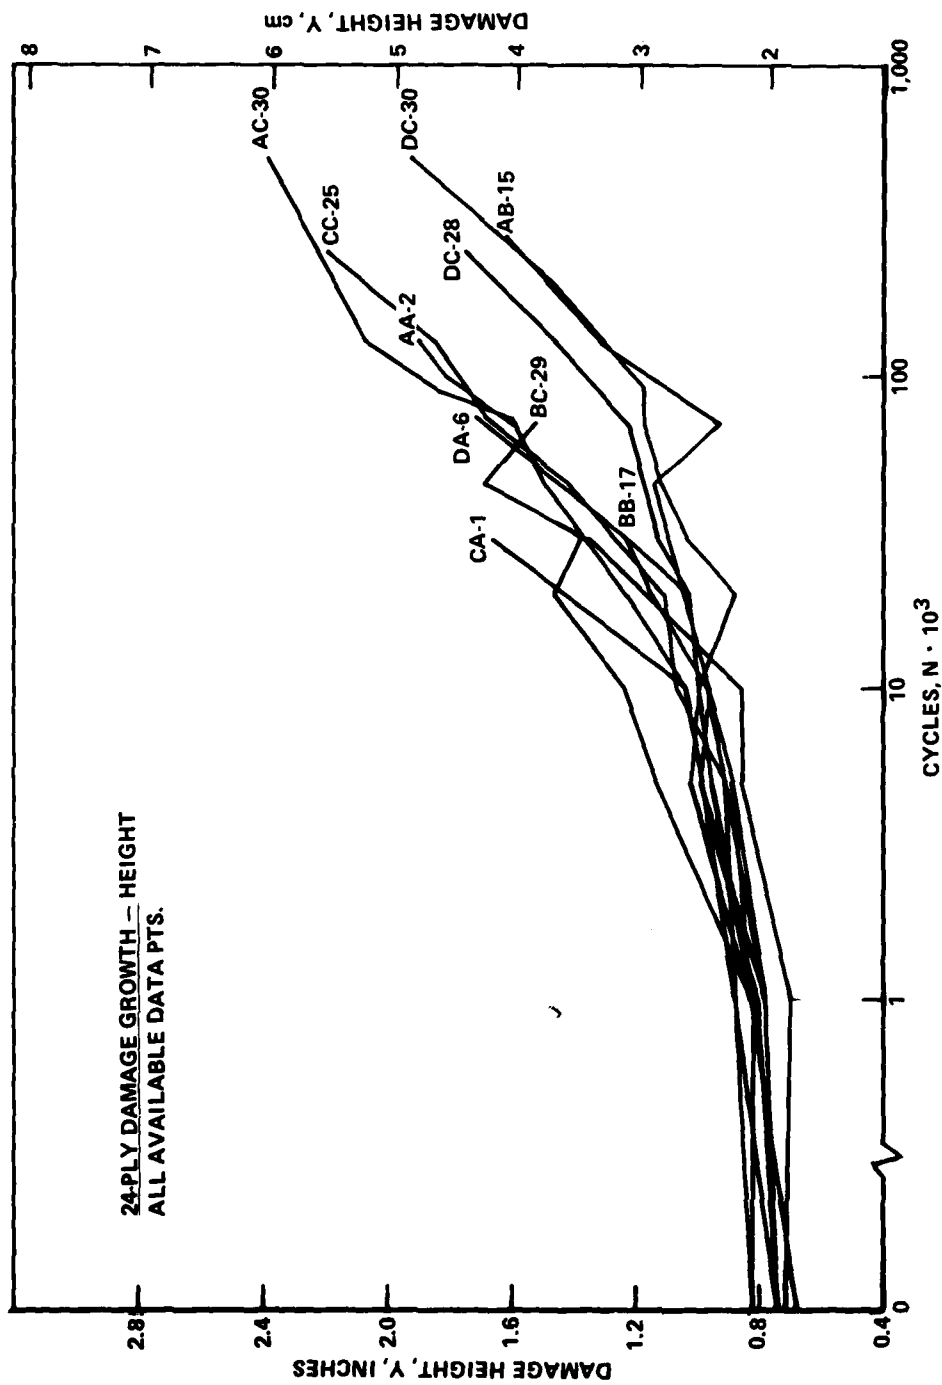
Figure 66a: Damage Growth in Height Dimension for the 24-Ply Fatigue Distribution Specimens (Specimens 1 thru 10).

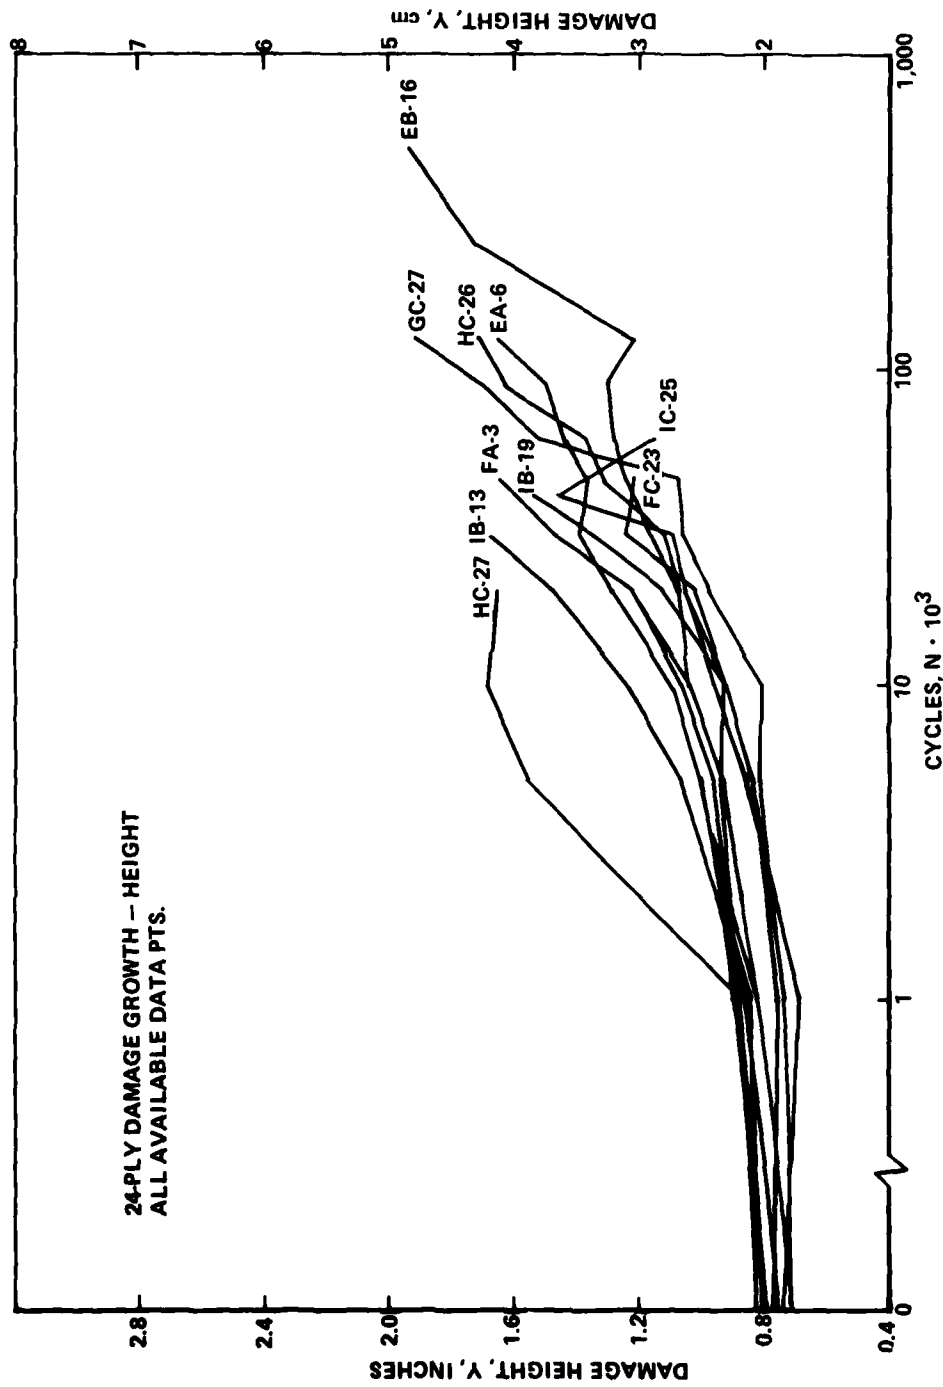
Figure 66b: Damage Growth in Height Dimension for the 24-Ply Fatigue Distribution Specimens (Specimens 11 thru 20).

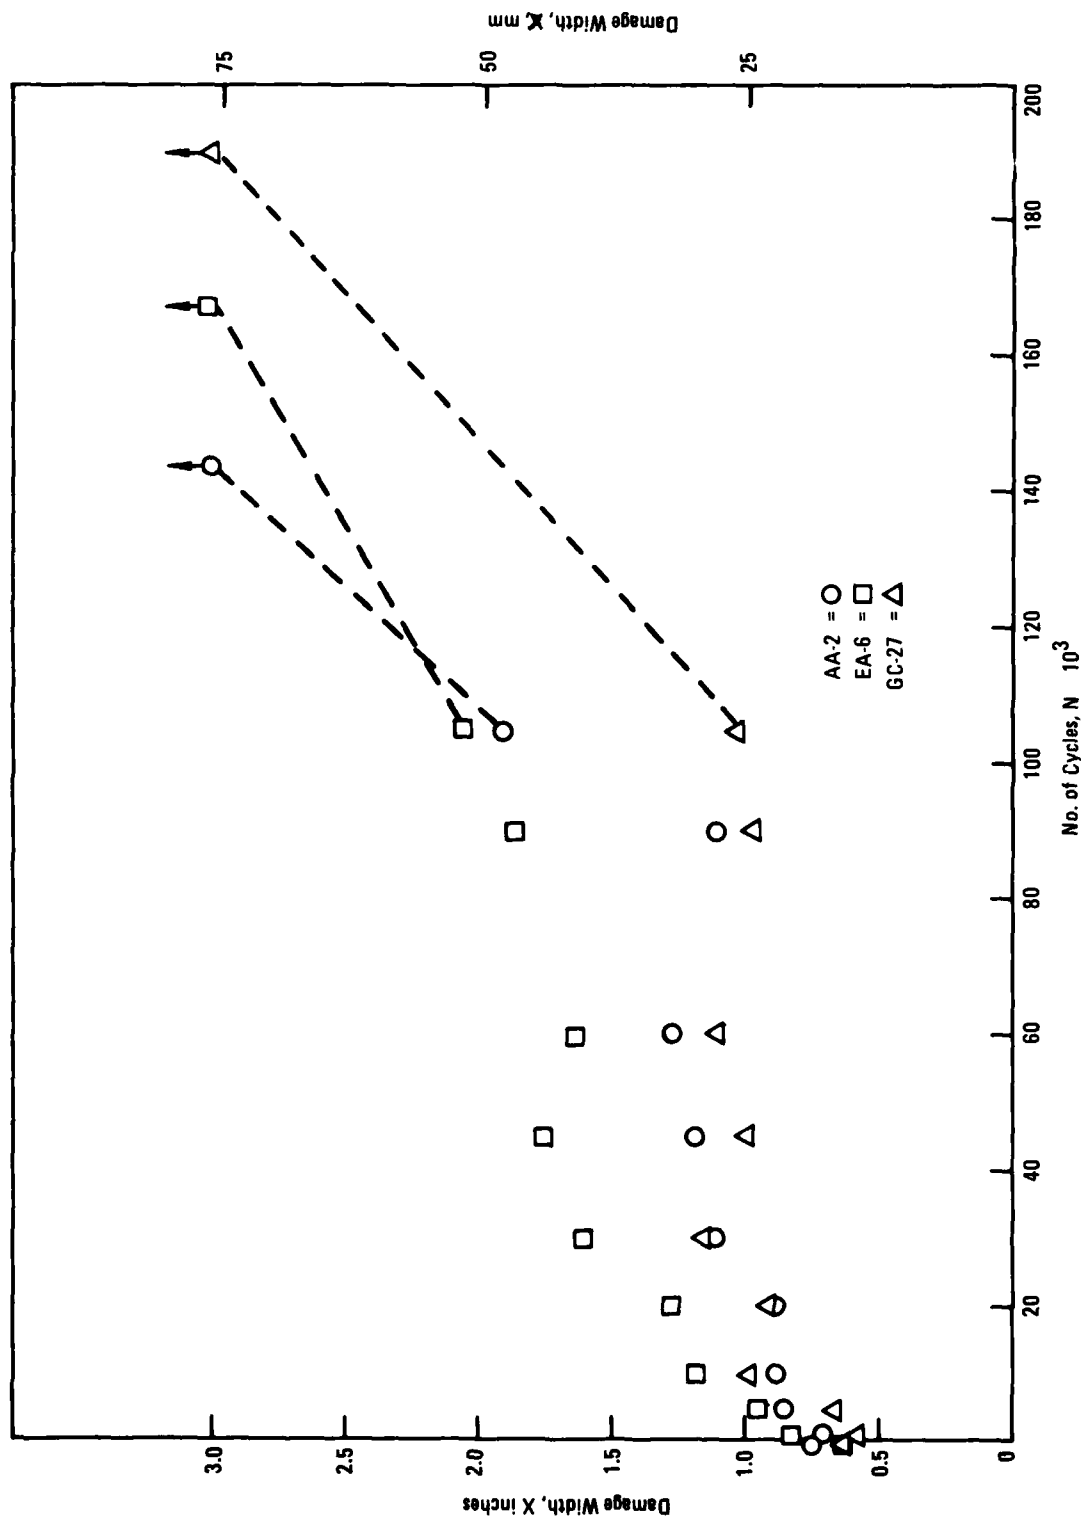
Figure 67: Damage Growth Behavior of Typical Longer Lived 24-Ply Laminate Specimens

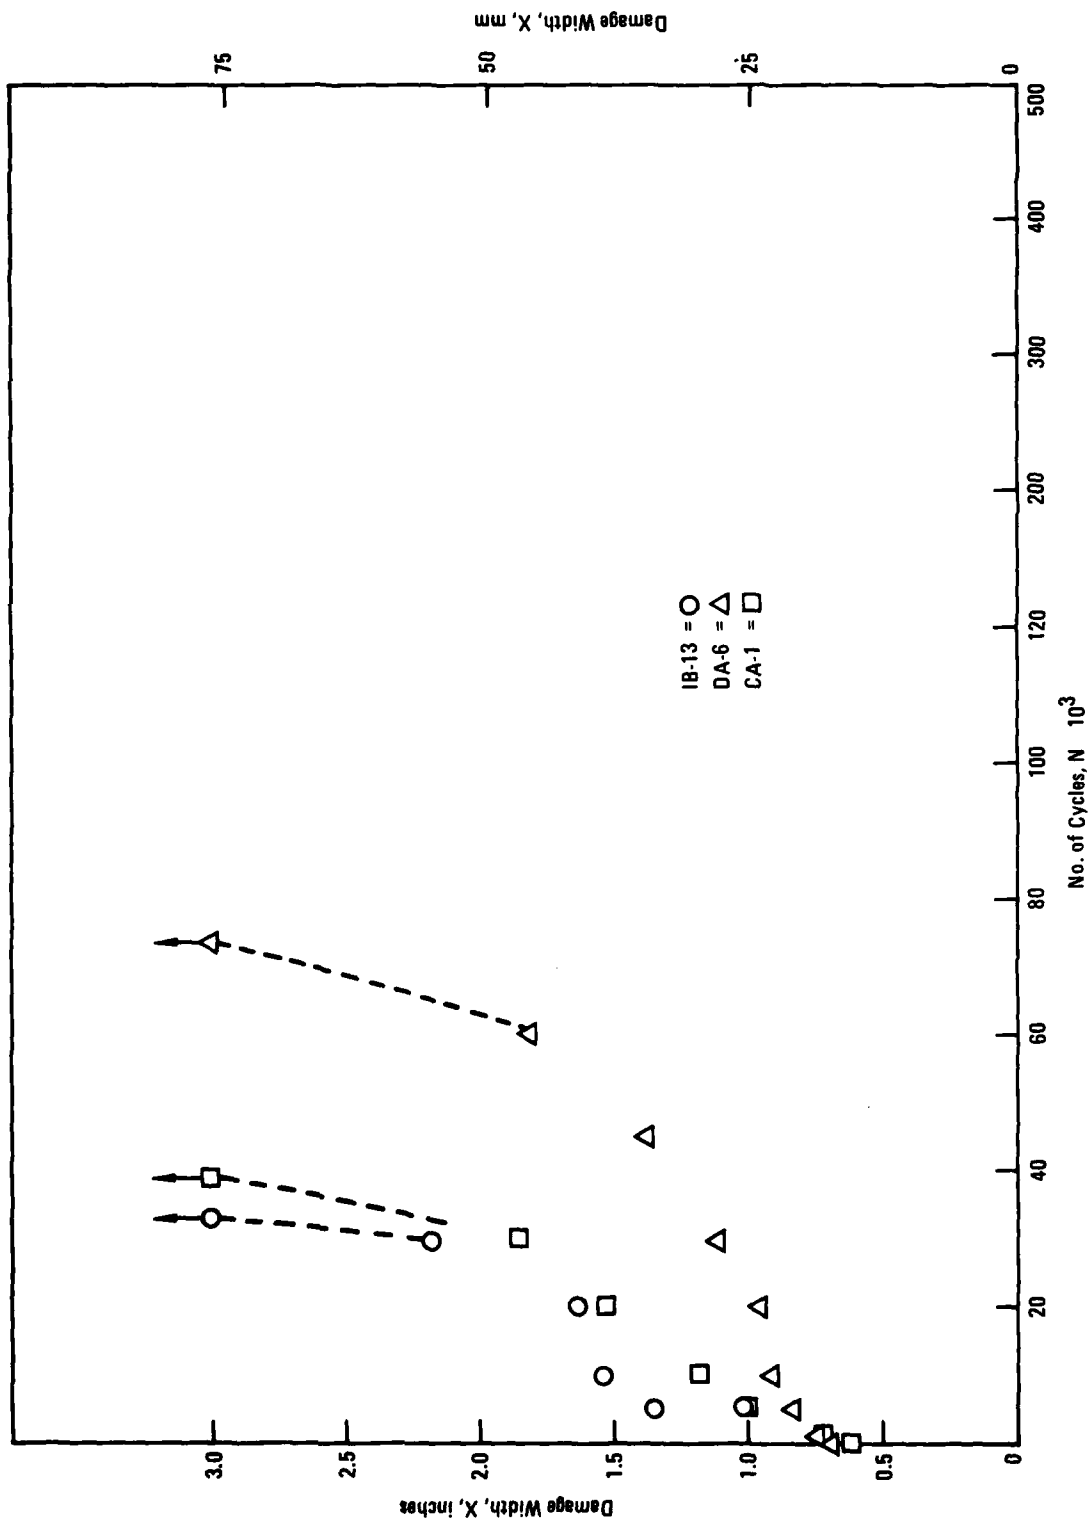
Figure 68: Damage Growth Behavior of Typical Shorter Lived 24-Ply Laminates
Specimens

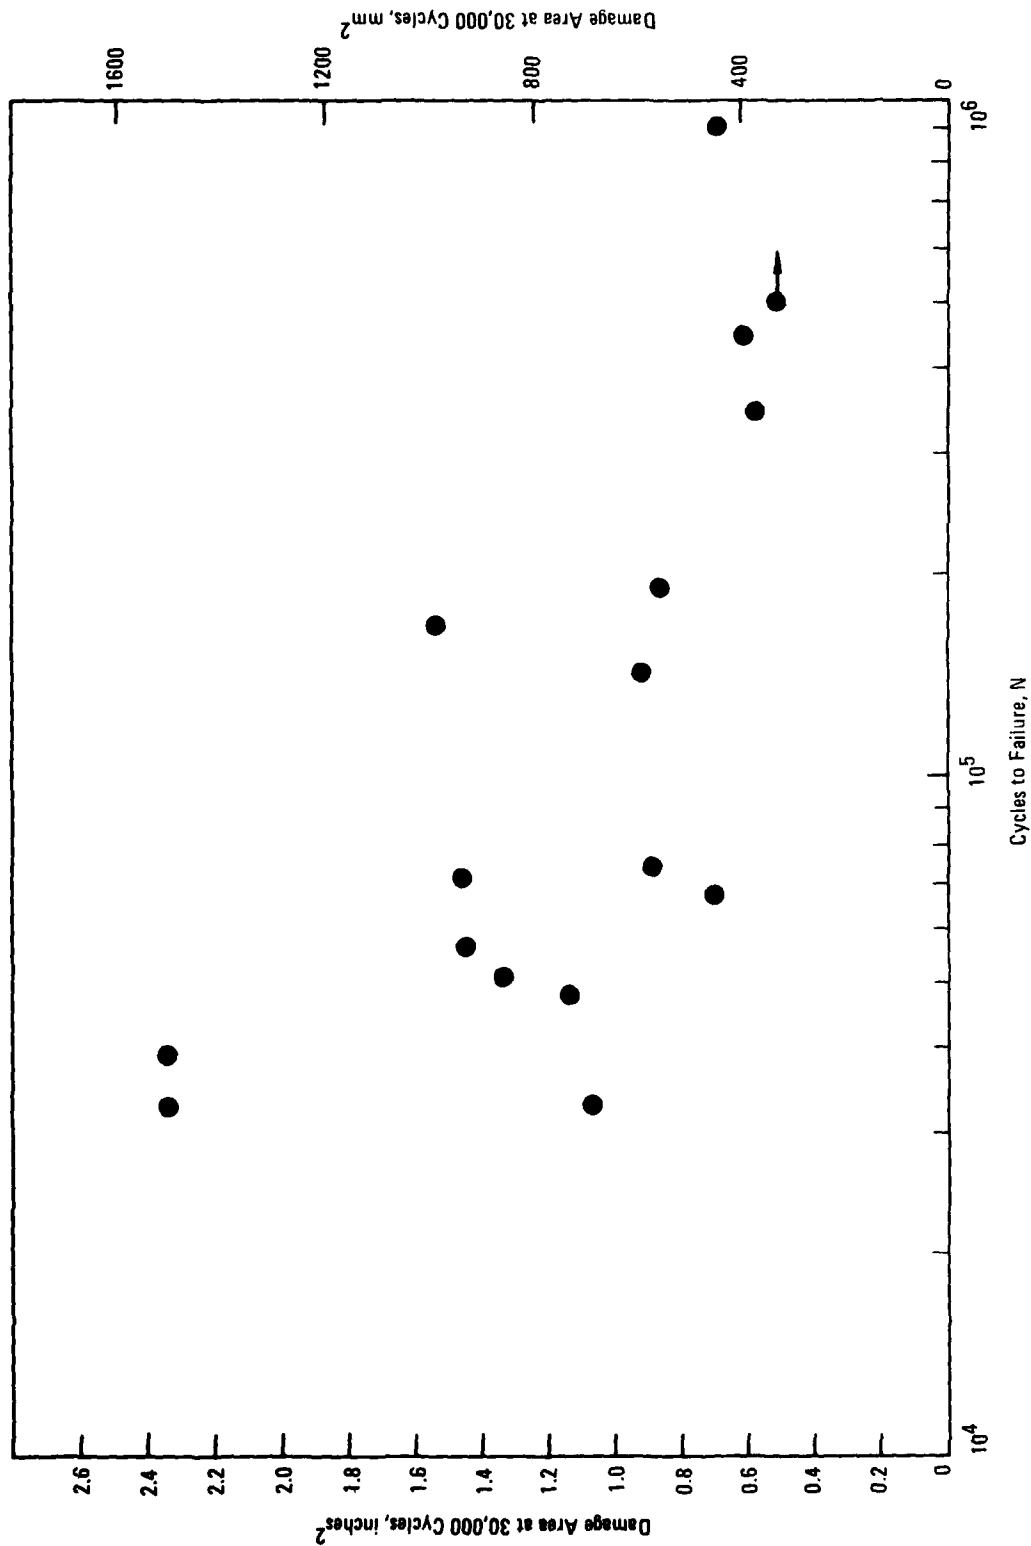
Figure 69: Damage Size at 30,000 Cycles vs Life for the 24-Ply Laminate

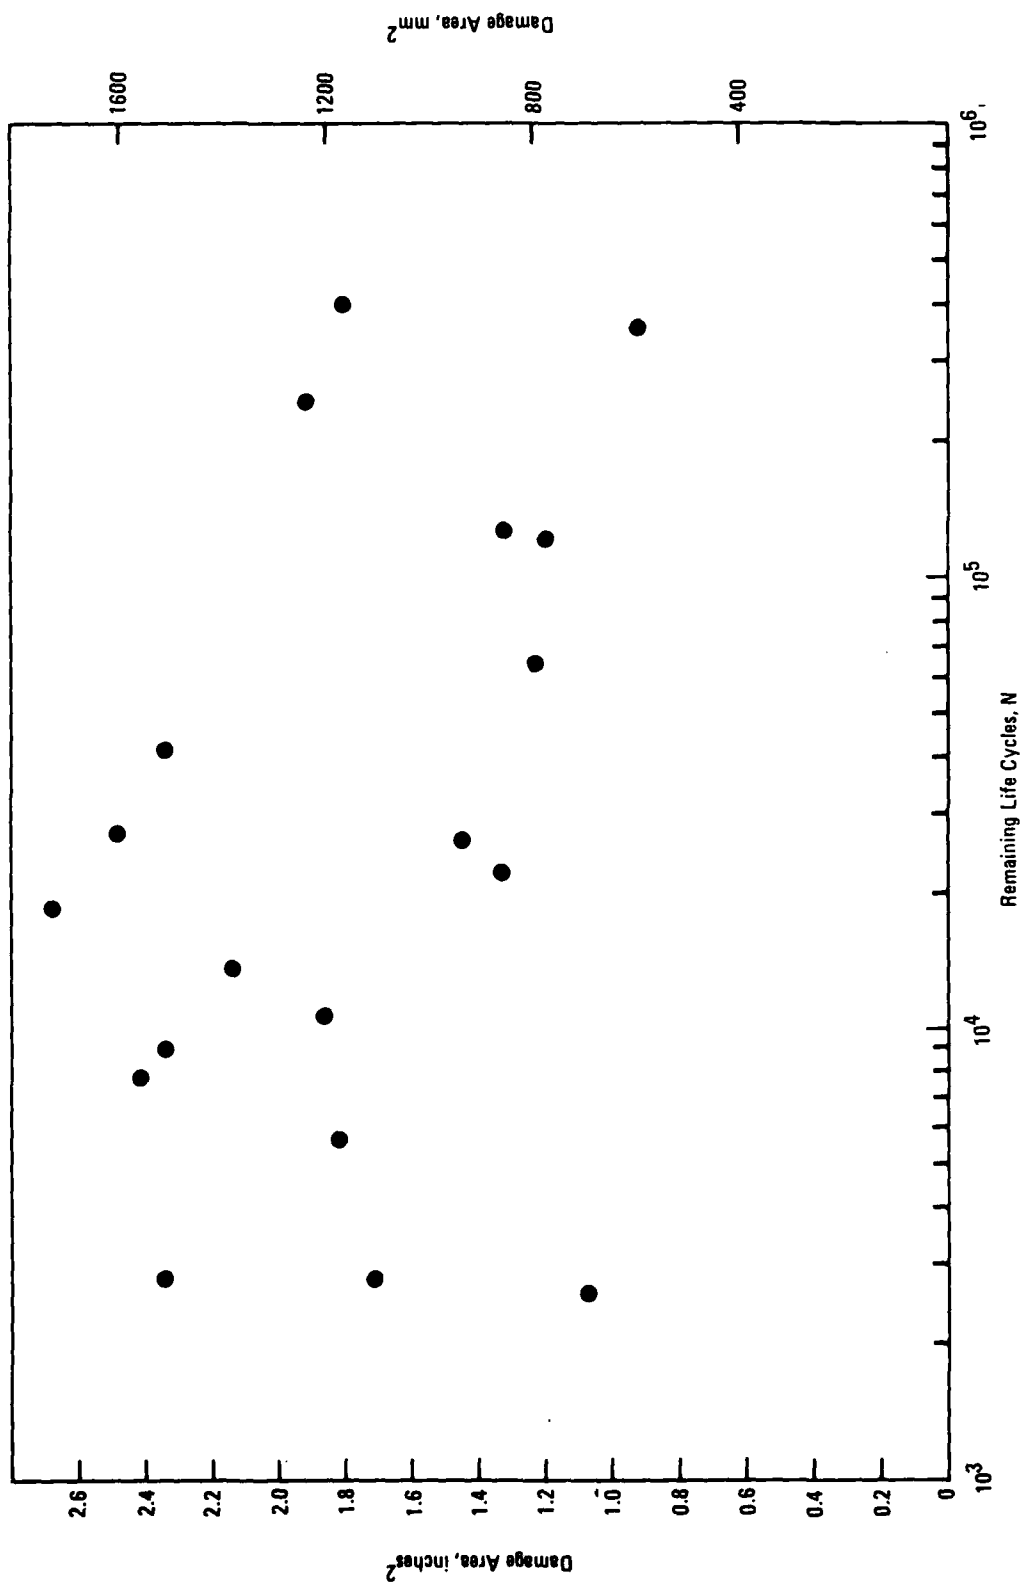
Figure 70: Last Recorded Damage Size Prior to Failure vs. Remaining Life For
The 24-ply Laminate

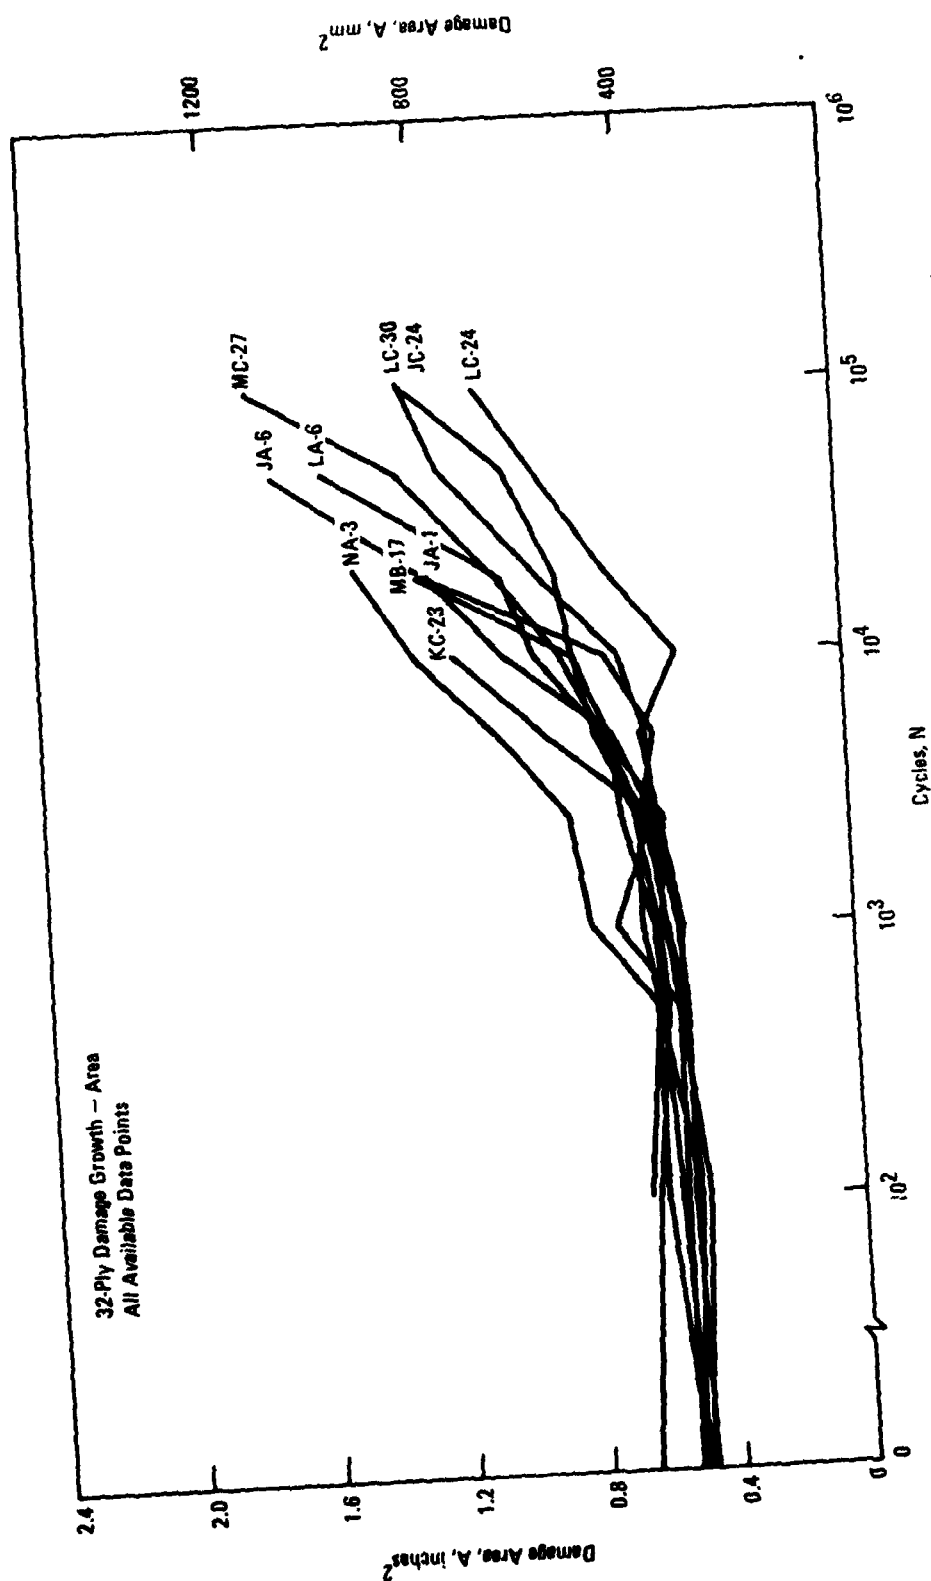
Figure 73a: Area Damage Growth for the 32-Ply Fatigue Distribution Specimens (Specimens 1 thru 10)

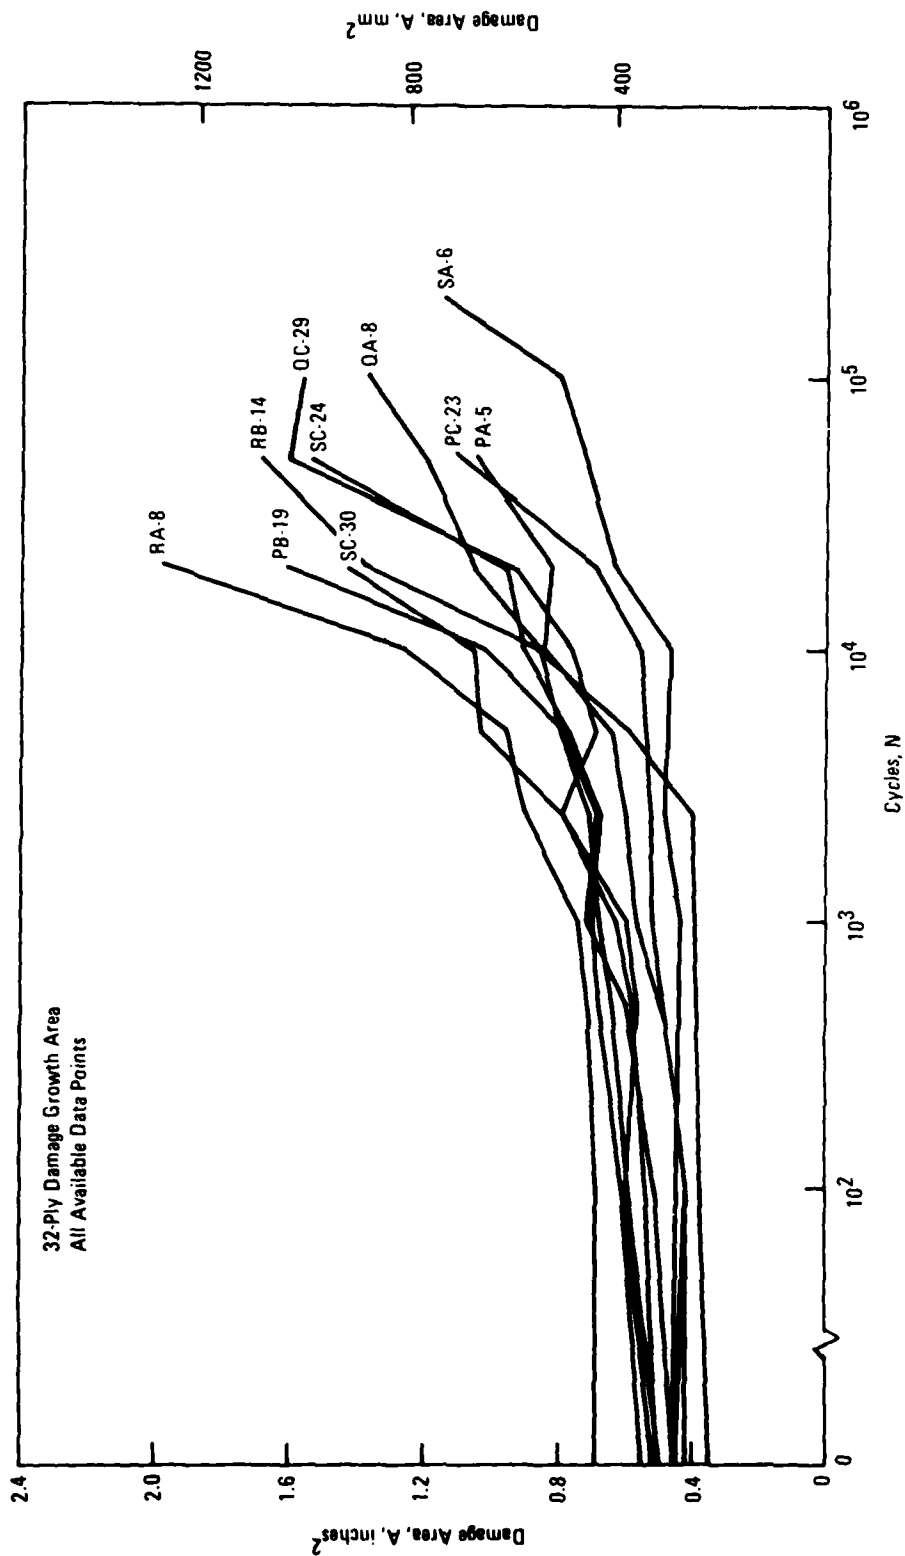
Figure 73b. Area Damage Growth for the 32-Ply Fatigue Distribution Specimens (Specimens 11 thru 20)

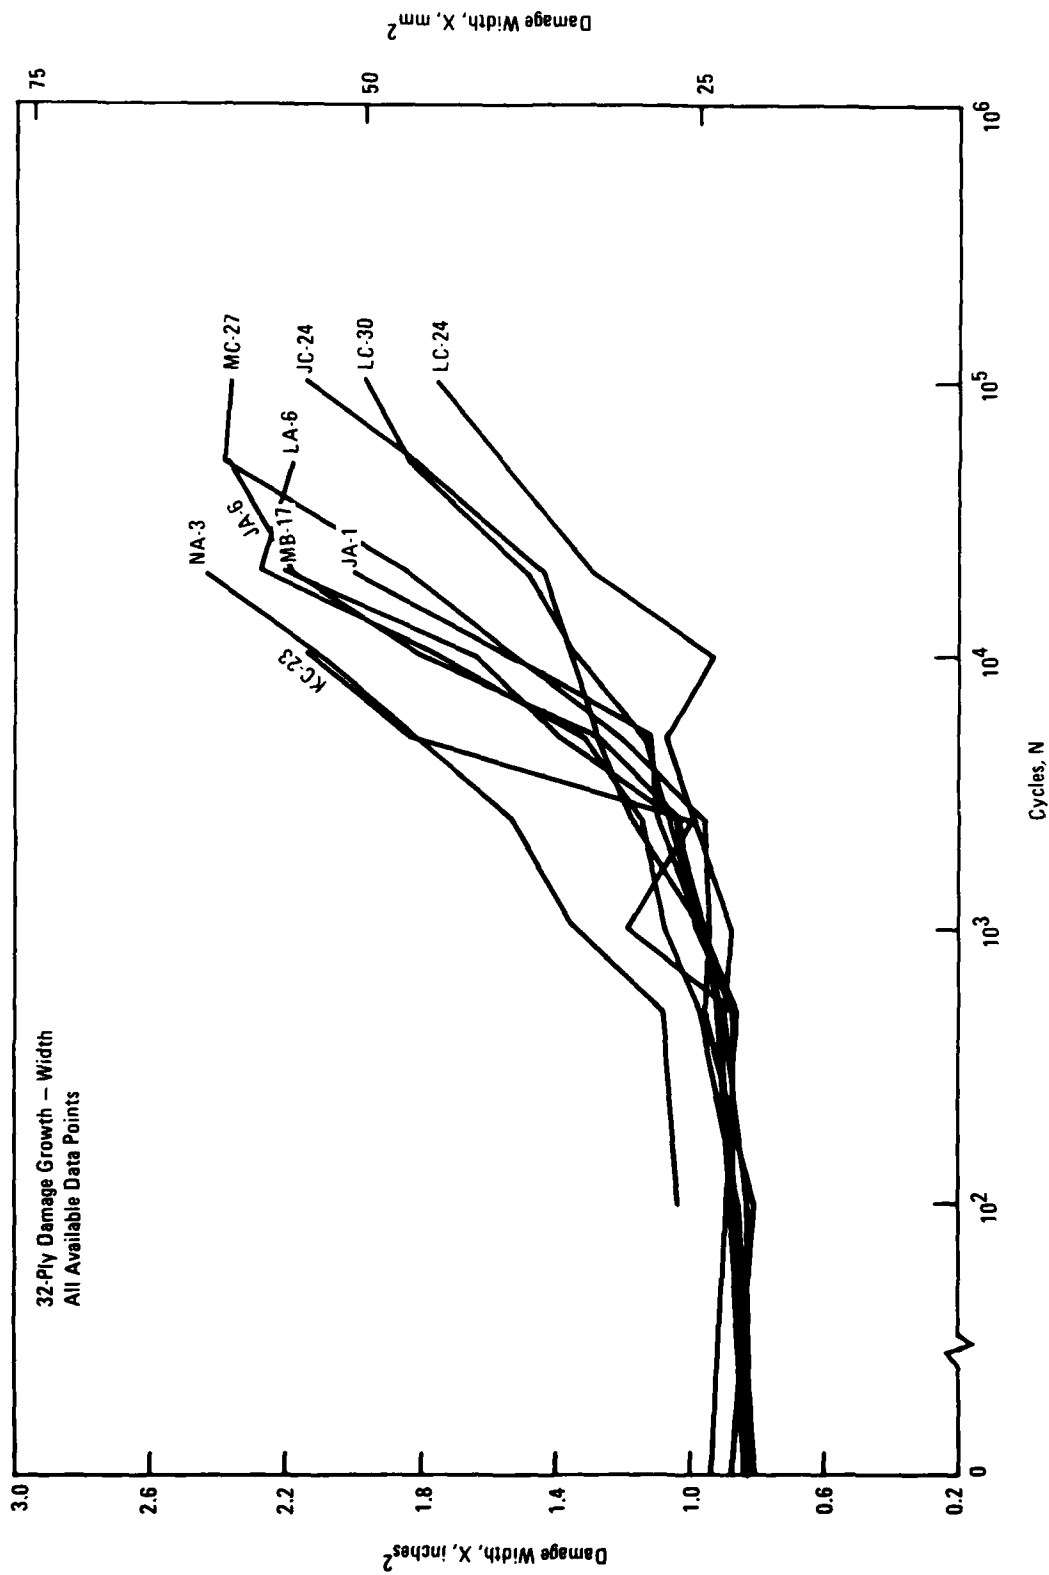
Figure 74a: Damage Growth in the Width Direction for the 32-ply Fatigue Distribution Specimens (Specimens 1 thru 10)
